Metals in America's Historic Buildings

Uses and Preservation Treatments

Part I. A Historical Survey of Metals

Part II. Deterioration and Methods of Preserving Metals

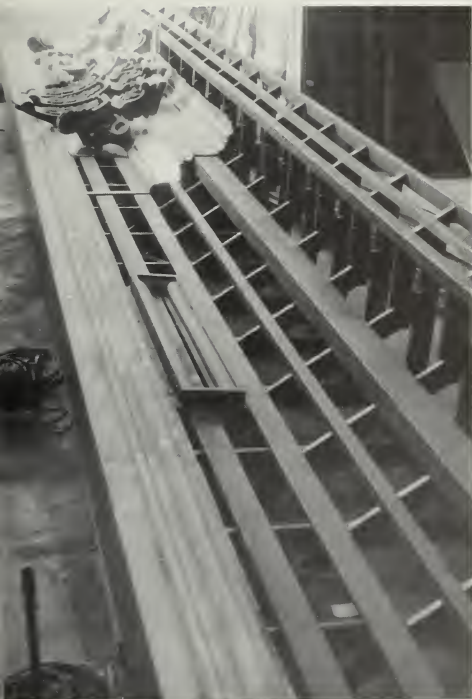
Figure 143. Preassembling Cornice. As illustrated in figure 12, most sheet-metal cornices were supported by wooden support members projecting out from the facade of the building, either as an extension of the roof framing or as a cantilever from a parapet wall. In either case, these wooden support members are often found to be rotten and have to be replaced. For large cornices high above the street level, it may be economically unfeasible to use scaffolding for in situ repairs and reconstruction unless the scaffolding is also needed for other work. The entire galvanized sheet-iron cornice of the ZCMI Store in Salt Lake City, Utah, was preassembled on the ground with repaired original parts and new pieces onto a new support system fabricated on mild steel angles. Fifty-foot sections of the preassembled cornice were then hoisted to the top of the facade and bolted to the building without the need for scaffolding. (Steven T. Ford)

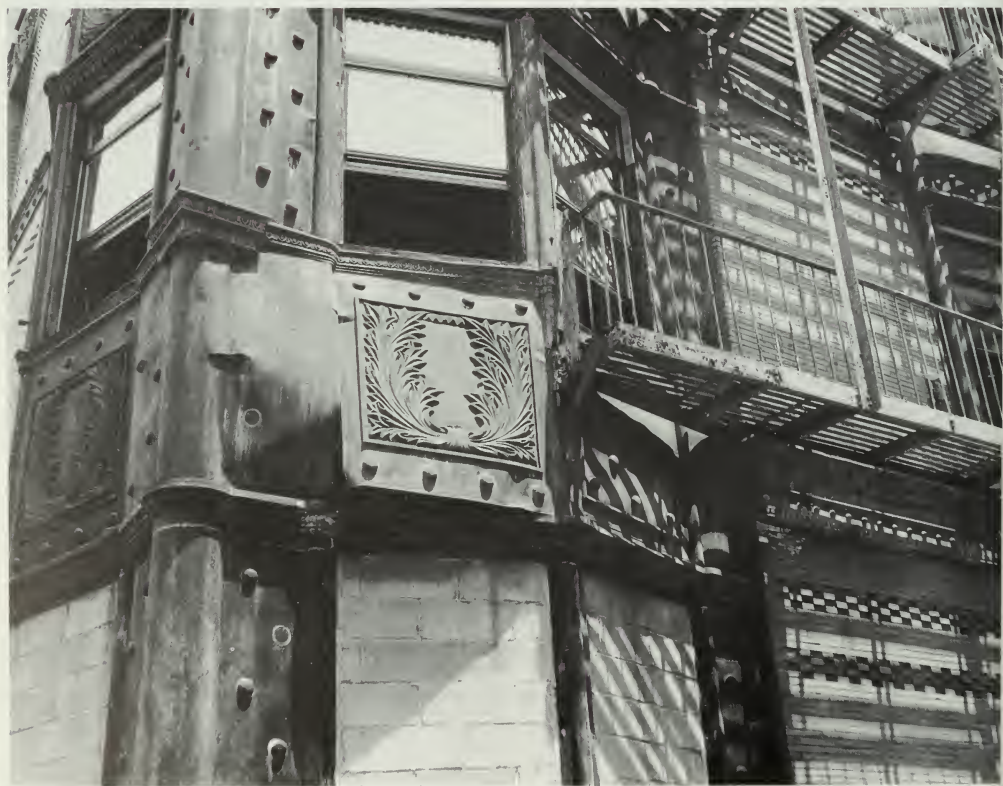
Figure 146. Loose and Damaged Copper Cladding and Deteriorated Steel Fire Escapes. The corner bay of the Hotel Margaret (1889) in Brooklyn Heights, New York, was clad in ornamental panels of pressed sheet copper. Anchors have deteriorated and the wind has lifted the corners. Galvanic action between the noble copper and the baser steel (in the fire escape) has caused the steel to deteriorate. (David W. Look)

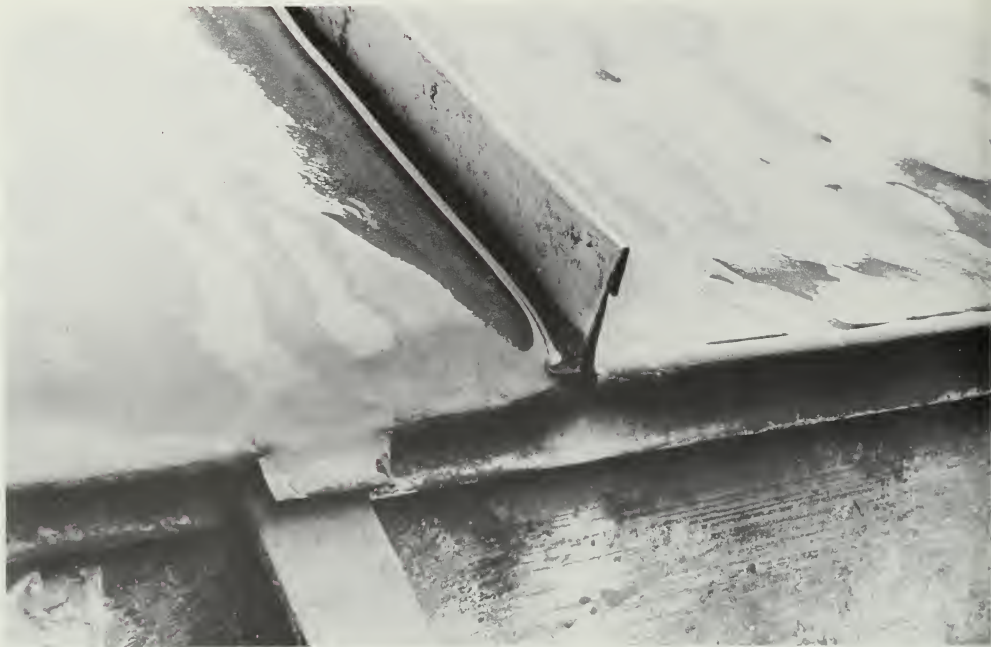
Figure 150. Erosion of Copper. This caves detail of the 1920s copper roof on the Senate House State Historic Site in Kingston, New York, illustrates erosion of the copper at the edge of the roof caused by continued exposure to rain and snow, which scoured the roof as it flowed to the gutter. Fatigue failure has also occurred at the base of the standing seam, resulting in a tearing of the copper. This failure was caused by the lack of provision for expansion and contraction, as well as the use of bituminous roofing felts, which restricted the movement of the copper. (John G. Waite)

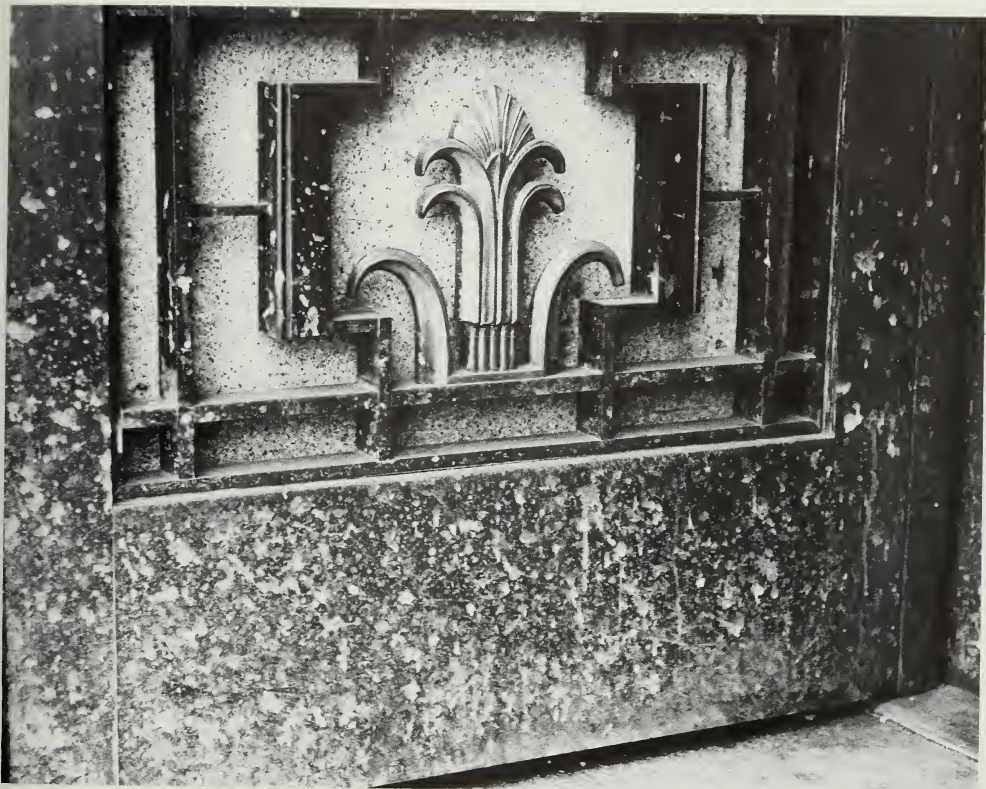
Figure 152. Snow Salt Damage. On the Circuit Court of Appeals Building in Washington, D.C., the lower extremities of the exterior-bronze gates are discolored and unsightly from repeated splashing of snow-removal salt. As long as the salt remains on the gates, the bronze will continue to deteriorate and its surface may even become pitted. (David W. Look)
